PEDDIE LAKE DAM

NJ 00149

PHASE 1 INSPECTION REPORT
NATIONAL DAM SAFETY PROGRAM

MARCH 1980

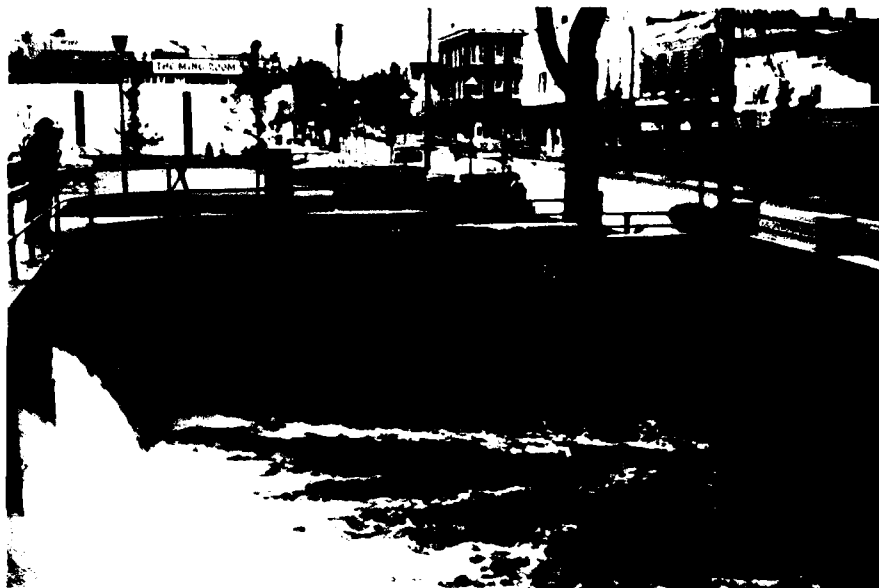
PHOTO 3

SOUTH DOWNSTREAM TRAINING WALL

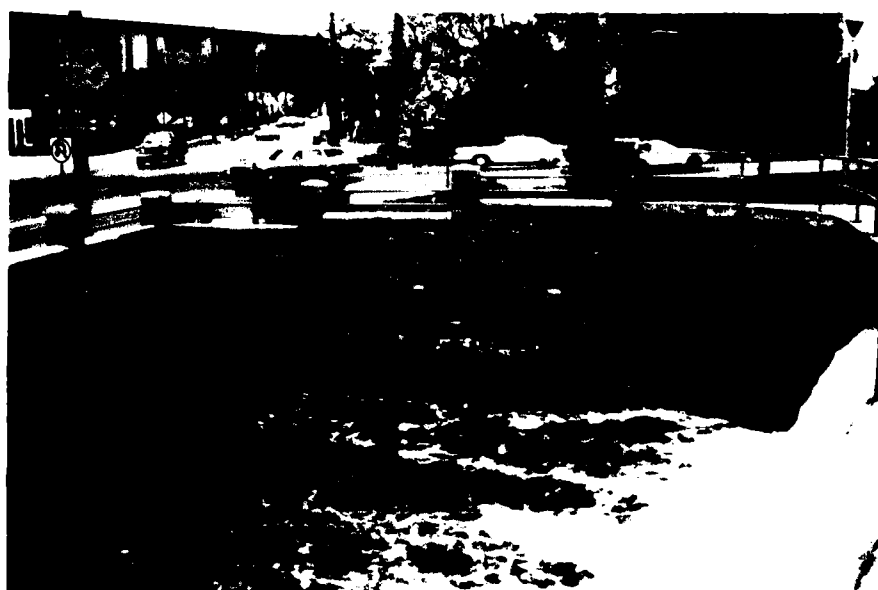
PHOTO 4

NORTH DOWNSTREAM TRAINING WALL

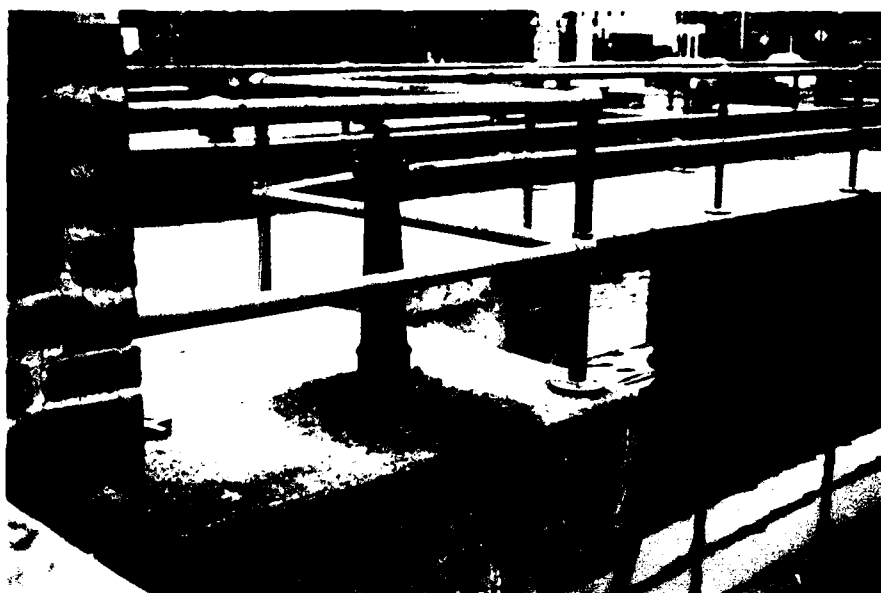
PHOTO 5

The outlet works operating mechanism at the south end of the dam is mounted on a concrete slab which is an extension of the walkway. Beneath the slab, the concrete wall on which the gate is mounted was spalled above the water line. The gate lift stem was rusted but appeared to be sound.

OUTLET WORKS OPERATING MECHANISM

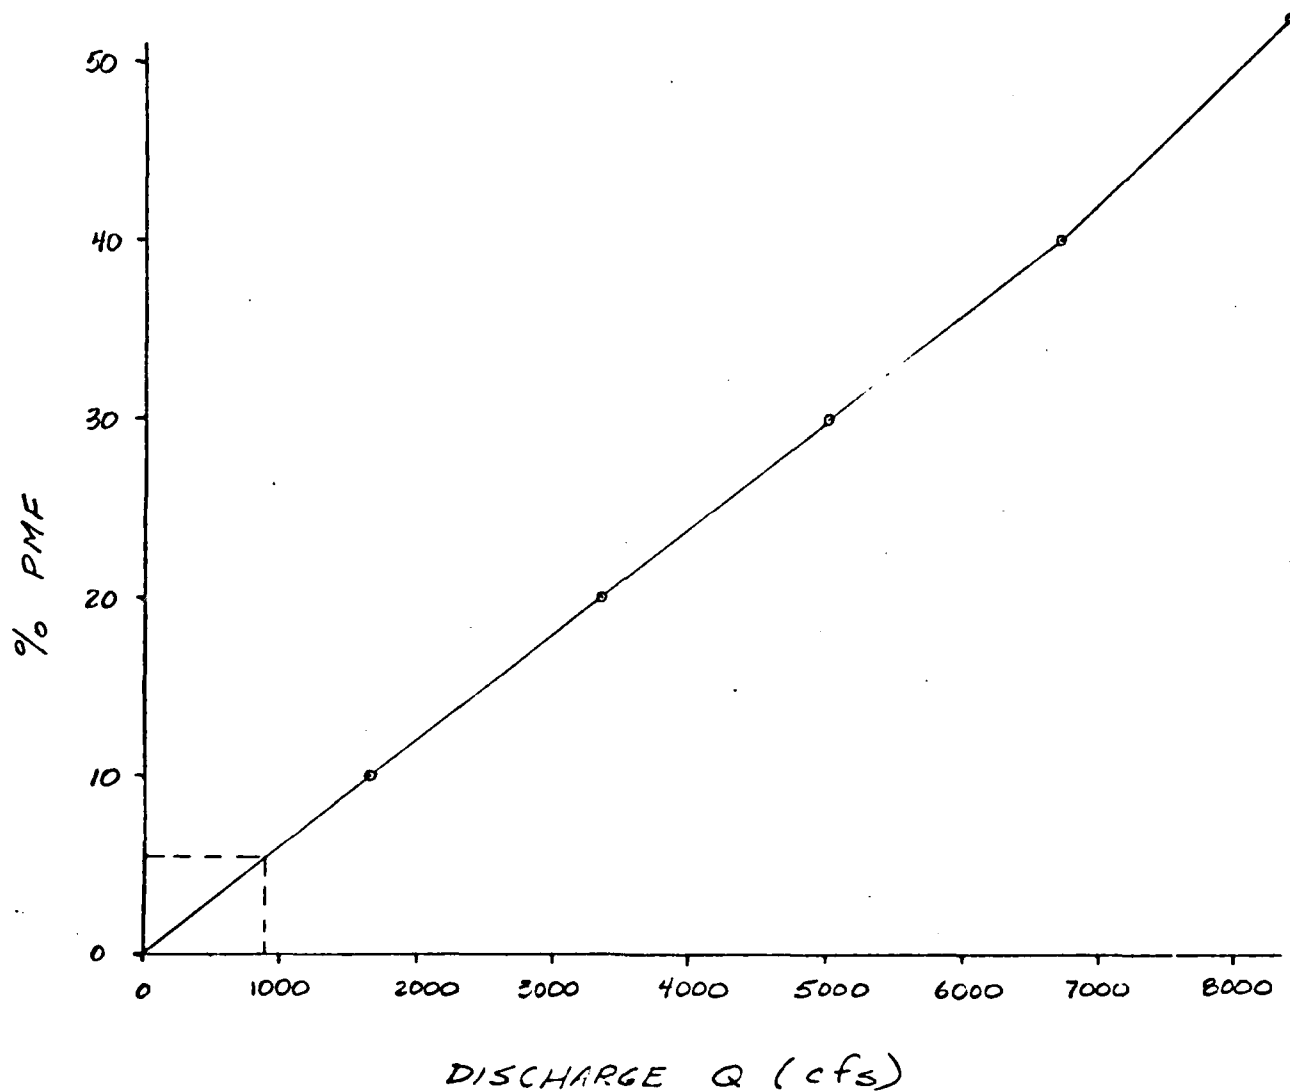
OVERTOPPING POTENTIAL

As indicated in paragraph 5.1.a, a storm of magnitude equivalent to the SDF would cause overtopping of the dam by a height of 3.2 feet above the top of dam. The spillway is capable of passing approximately 12% of the SDF with lake level equal to the top of dam.

DAM CAN PASS 6% of PMF
OR 12% of SDF

Based on hydraulic and hydrologic analyses outlined in paragraph 5.1.a, the spillways are considered to be inadequate. It is therefore recommended that a professional engineer experienced in the design and construction of dams be engaged in the near future to perform more accurate hydraulic and hydrologic analyses. Based on the findings of the analysis, the need for and type of remedial measures should be determined and then implemented.
